Ref: TT0048  
V1.0

## MDR - IP Camera Not Working with MDR 641

### Related Products - MDR 641 & IP Cameras

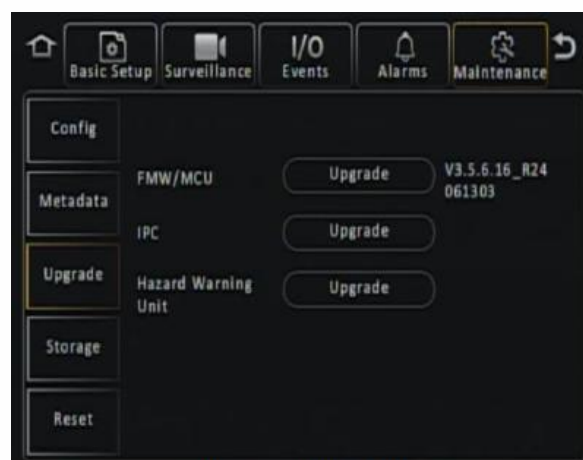
Upgrade Figure 140

We have had some issues reported to our Technical Support Team regarding IP Cameras not working with an MDR 641 installation. After investigation we have found that this is due to an older firmware version being installed on the MDR. The solution would be to upgrade the MDR 641 firmware to the latest version.

Create a folder named **upgrade** in the root directory of your USB flash drive. Copy firmware files (combined FMW and MCU). Plug the USB flash drive into USB bus-powered hub which is then connected to the front of the MDR. Click upgrade to start the upgrade process, see *Upgrading Progress Figure 141*. After the upgrade, the MDR will restart and display *System Upgrade Figure 142*. Check if the firmware/MCU version has been upgraded successfully by checking system information.
