Related Products - Mobile Digital Recorder MDR 500 Series and MDR-644

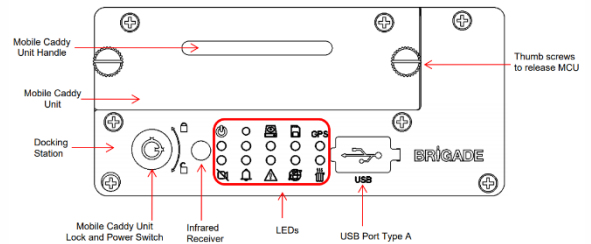
To confirm if the alarm is due to Video Loss check the LEDs on the front of the MDR. If the **Alarm**

and **Video Loss**

Red LEDs are on, this indicates video signal loss which could be as a result of camera or camera connection failure.

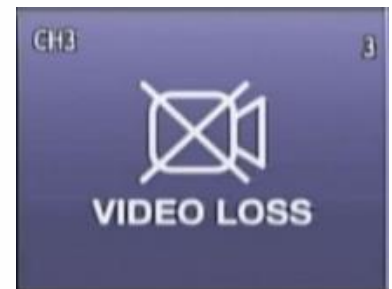
Video loss can also be confirmed by the **Video Loss** image on the monitor. The Channel (camera) number may be shown in the top left corner to identify the channel number at fault.

Once the camera or connection has been fixed the alarm will no longer sound and the camera image will be restored on the monitor.
